Location : Greece – R.o.W.

Incident Type :HIPO Near Miss
PIPE SLIP

Date: 09/01/2017

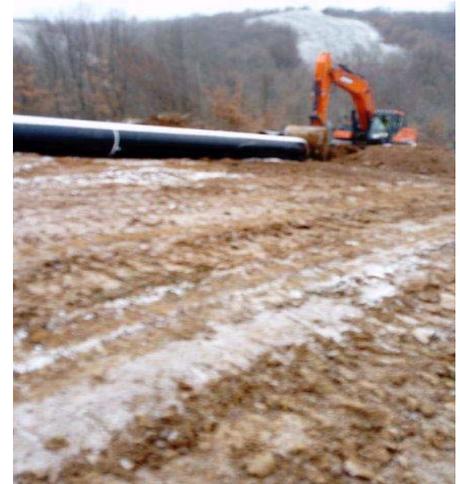
An excavator operator which was working in the line of fire, used the bucket of the excavator to stop the pipe march. Despite the fact that the sliding pipe was moving slowly, the excavator was pushed back approximately 2 metres from the weight of the pipe. The operator did not suffer consequences from the event.

The moment the excavator stopped the pipe

Method statements in use shall be revised to ensure that they are aligned with the current best practices from the international standards.

All personnel shall be trained on working on steep slopes and in combination with ice and inclement weather.

Conditions of all pipe strung on slopes to be assessed meticulously.

Warning signs to be installed at all slopes indicating the slope category and further signage shall address the issue not to stay/work in zones below areas where pipe movement is carried out

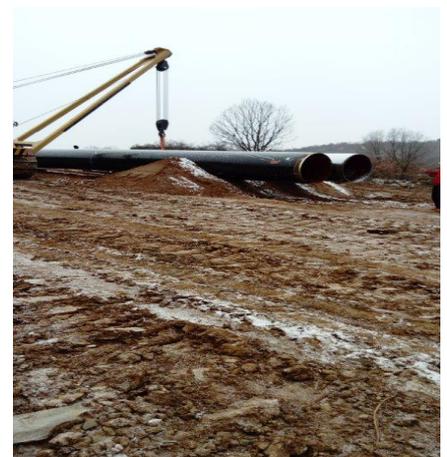
While preparing the area for the automatic welding activities on an incline, in the action of lifting one pipe that had to be welded, the moment that the pipe was starting to being lifted by the side-boom, an adjacent pipe slipped from the skid crotch and the earth berm and slid towards the lower part of the slope, for the length of approx 25 metres.

The cause of the near miss according to testimonies and analysis is to be ascribed to vibrations, most likely caused by the excavator during the compaction of soil.

Icing and cold weather also played a critical role in the occurrence

The layout at the moment the pipe slipped
