SAFETY Alert

03/2014

Rupture of a buried electrical cable 20 000 V

ISSUED BY: QHSE DEPARTMENT

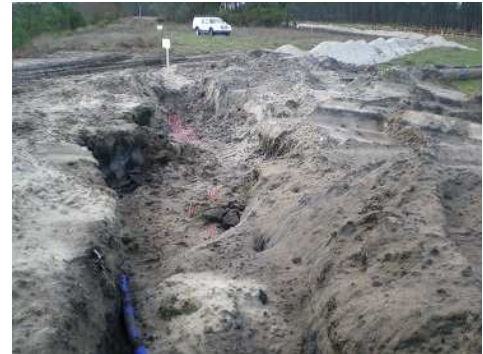
During the positioning of drains under-conduct performed by a subcontractor, the trencher broke an electrical buried cable 20 000V. No member of the working team has realized that the incident occurred (no visual or materials indication, no noise), due to the noise and the earth-moving produced by the trencher. Subcontractor's staff became aware of the rupture of the electric cable following the arrival on site of the personnel of the energy distribution company; they arrived to check what happened after a call received by an owner. None of the subcontractor has suffered any physical injury (including trencher operator).

- *Failure to follow the process to be applied;*
- *Lack of organization;*
- *Lack of skills in the process of identifying buried network;*
- *Inadequate leadership/supervision.*

- ✓ Electrical cable broken (HTA 20 000 Volts) was repaired following the intervention of the personnel of the energy distribution company;
- ✓ Meeting with responsible of the energy distribution company;
- ✓ Update the table showing the surveys and combining data with those provided by the energy distribution company;
- ✓ Update all the alignment sheet;
- ✓ Reorganize the management of documentation (alignment sheet, etc..) and surveys;
- ✓ Recall laws and rules relating to the management of the activities in the vicinity of network;
- ✓ Check on site to confirm the position of surveyed services and the services to be surveyed.
