SAFETY Alert

SOIL CONTAMINATION

OBJECT: SOIL CONTAMINATION WITH EPOXY COATING

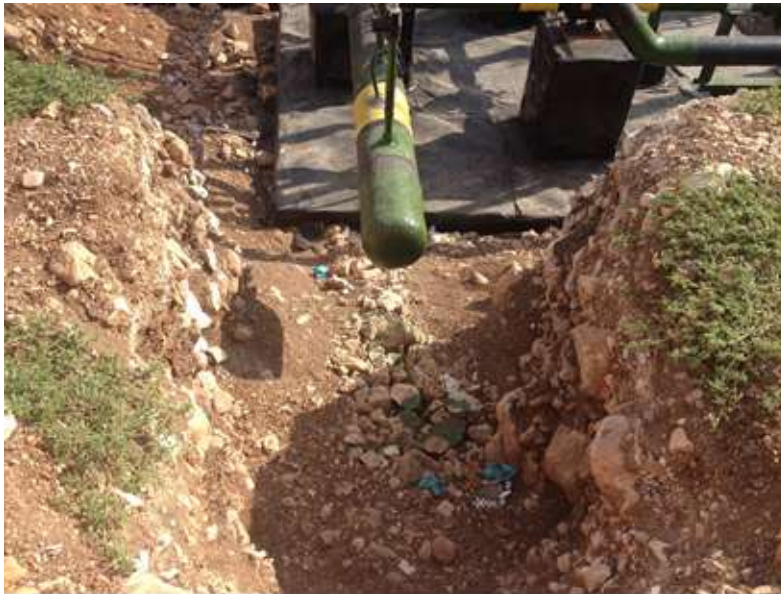
A spill of epoxy coating material was detected on soil surrounding below-ground station pipework at a Valve station. It was subsequently discovered that the spill occurred during the application of the epoxy coating to station piping. Contamination was confined to the immediate area surrounding the station pipework and contamination of ground water systems did not occur.

- A lack of knowledge and training of the coating crew with regard to the correct handling and disposal of the epoxy material;
- A lack of supervision and instructions to the coating crew subsequent to the application of the epoxy.

- ✓ Contaminated area removed isolated and placed in bag for disposal as hazardous waste;
- ✓ Task supervisors to ensure proper supervision of activities under their control and to notify the HSE dept. prior to first usage of new products/materials;
- ✓ Use of impermeable sheet under the joint during coating to contain the spill.

- ✓ Sicim HSE dept. to communicate the product MSDS to all coating personnel and to ensure the prompt communication of MSDS for all products to the relevant crews;
- ✓ Refresher training to be provided to all site supervision to ensure proper hazard identification of products and recognition of product symbols;
- ✓ Safety Alert developed and toolbox training regarding the circumstances of this incident to be communicated to all coating personnel.
