# NEW FLEXIBLE SYSTEM FOR ABRASION RESISTANT OVERCOAT

# ARROW EAGLE

**LK2** New Abrasion Resistant Overwrap providing superior mechanical protection and excellent performance.

## **PROJECT "HDD TERRE ARMATE"**

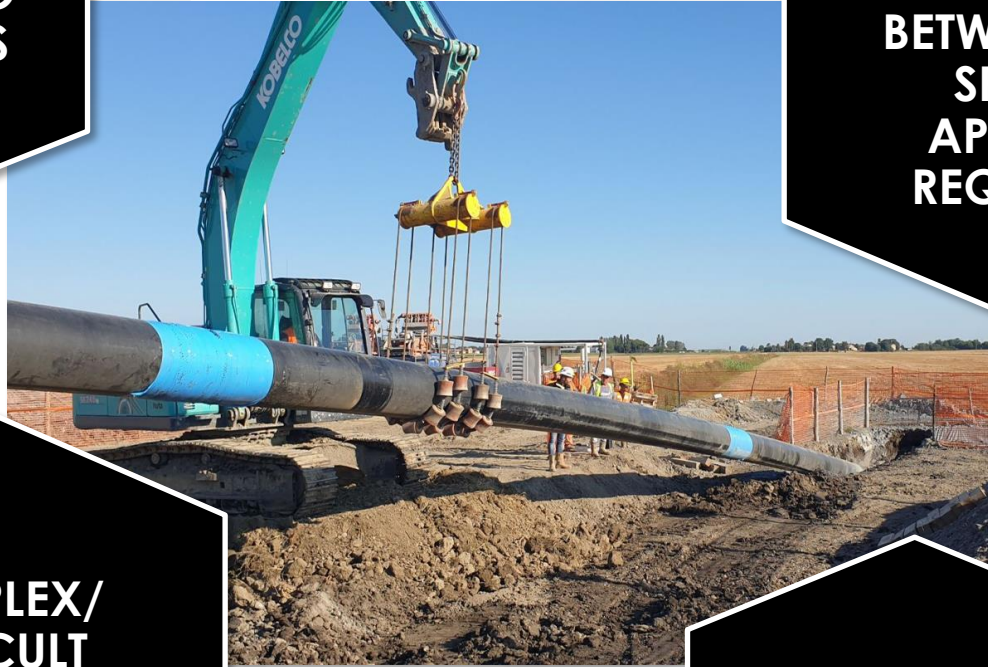
# **HORIZONTAL DIRECTIONAL DRILLING:** **COMMON ARO CRITICAL ISSUES**

**ONE  
PRODUCT TO  
FIT ALL PIPES  
SIZE**

**UNBALANCED  
CURING TIME  
BETWEEN DRYING  
SPEED AND  
APPLICATION  
REQUIREMENTS**

**COMPLEX/  
DIFFICULT  
APPLICATION**

**SHORT SHELF  
LIFE**

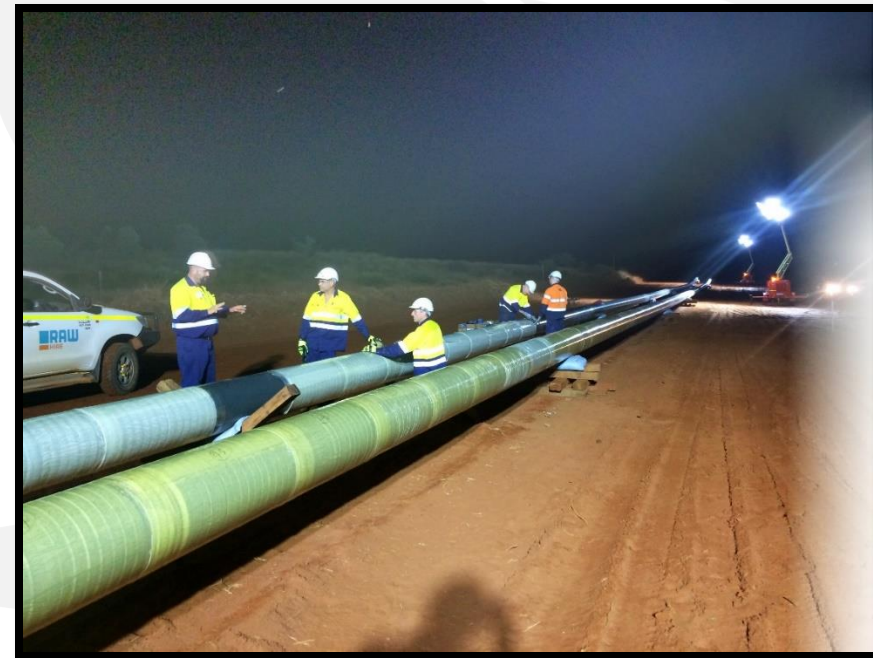
Example of Overnight application to avoid too fast curing

- Overnight application
- Too short curing time
- Unbalanced curing time between drying speed and application requirements (Especially in sunny countries)

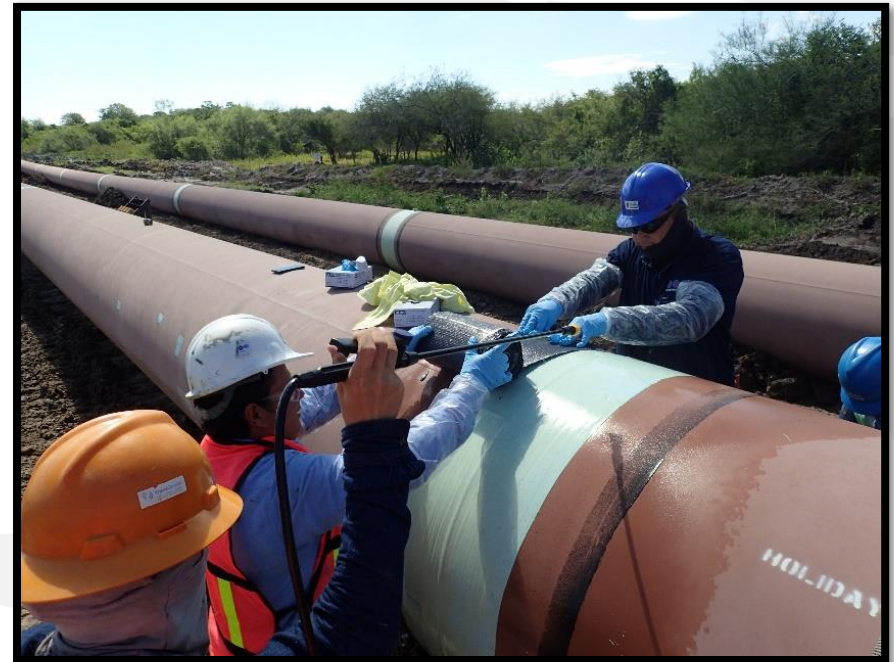
## WATER CURING PRODUCTS

- Easy to install
- High quality material

- Price level dramatically far from other products
- High risk to get cured rolls during transportation
- Short shelf life

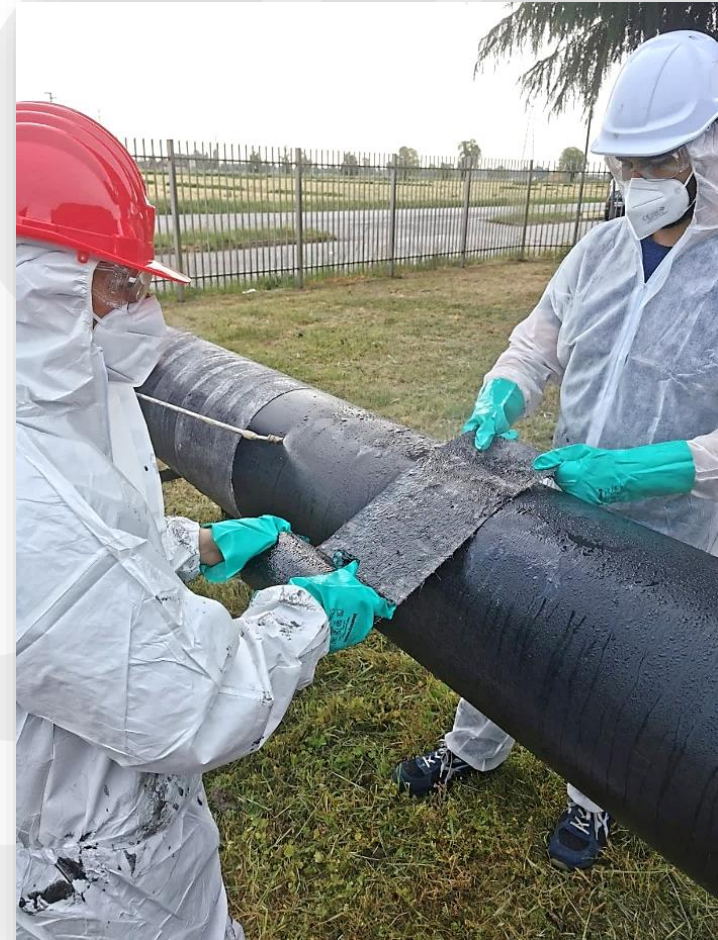
**AroEagle** is simply wrapped around the joint pipe and then activated by water. Supplied in different sizes and taylor-made to suite at the best accordingly to the customer pipeline diameter.

**AroEagle** is the right solution to protect with a sacrificial laminate your field joint coatings or mainline coatings (FBE, 3LPE, 3LPP, epoxies, sleeves and tapes): it consists of a fiberglass fabric, supplied in different thicknesses/sizes, impregnated with MDI based polyurethane resin which cures once activated by water (MCU).

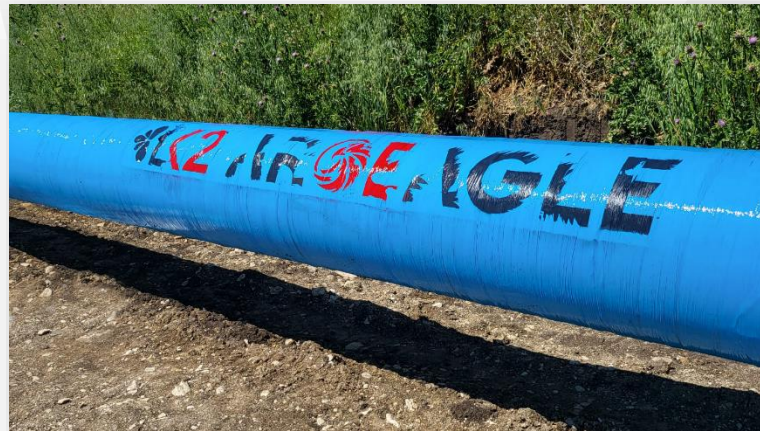
# AROEAGLE AVAILABLE SIZES

CODE	WIDTH	THICKNESS
EAGLE 250XL	250 mm	2,0 mm
EAGLE 150XL	150 mm	2,0 mm
EAGLE 150	150 mm	1,6 mm
EAGLE 150TH	150 mm	1,2 mm
EAGLE 100TH	100 mm	1,2 mm

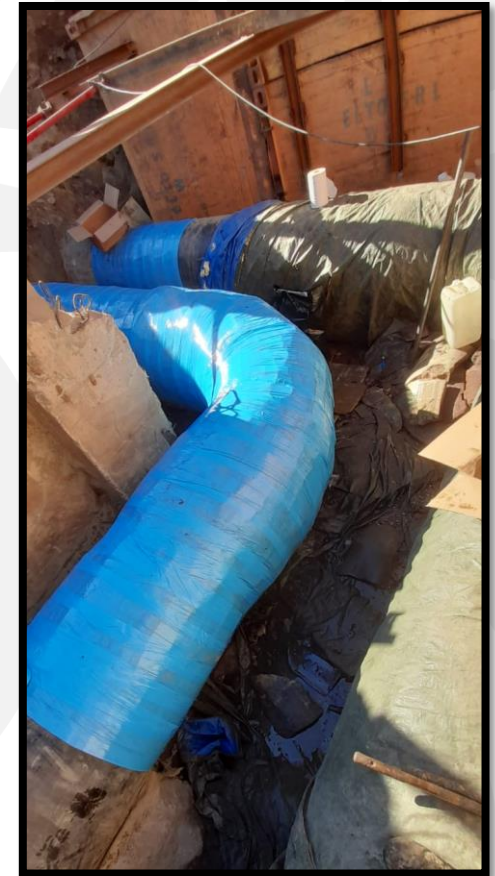
## Project: DN 100 (4'') GAS PIPELINE – RONCADELLE (BS)

DATE	FEBRUARY 2022
OWNER	SNAM
CUSTOMER	<b>SINTEC</b>
COUNTRY	ITALY
PIPE DIAMETER	4''
PIPE LENGHT	200 m
TYPE OF PROJECT	GAS LINE
COATED SECTION	Application on Total Pipe Length
GROUND CONDITION	Very harsh soil, rocky and pebbly ground
WEATHER CONDITION	9°C
Note	30 m crossing through a reinforced concrete basement of a pre-existing factory

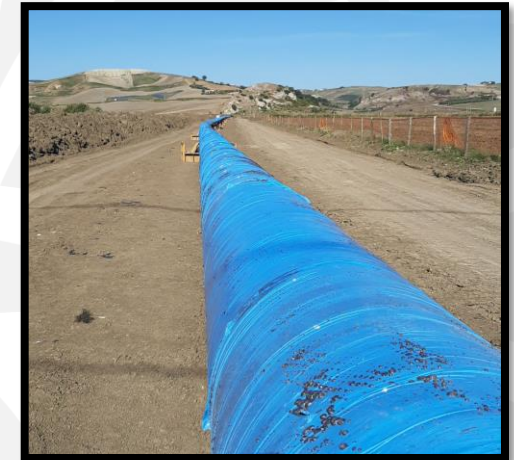
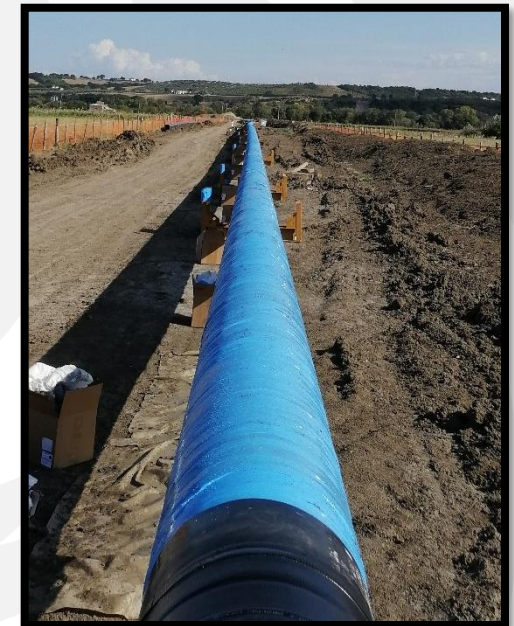
## TOC ATTRAVERSAMENTO FIUME LEMENE HDD LEMENE RIVER CROSSING

DATE	FEBRUARY 2022
OWNER	SNAM
CUSTOMER	<b>ROMANA COSTRUZIONI</b>
COUNTRY	ITALY
PIPE DIAMETER	16''
PIPE LENGHT	964 m
TYPE OF PROJECT	High Pressure Gas Transmission Pipeline
COATED SECTION	Application on Total Pipe Length
GROUND CONDITION	Dry, rocky
WEATHER CONDITION	12°C / Sunny
Note

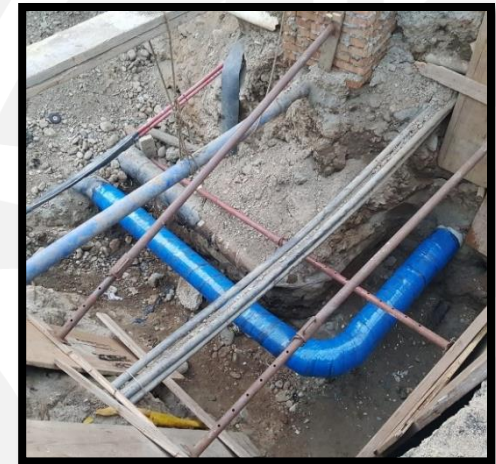
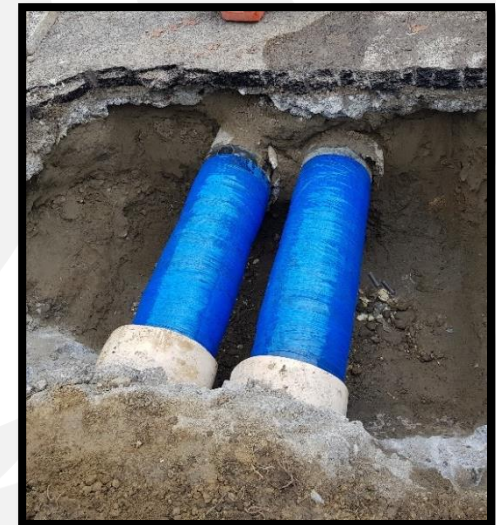
<b>DATE</b>	APRIL 2022
<b>OWNER</b>	<i>Confidential</i>
<b>CUSTOMER</b>	<b>IB Saldature</b>
<b>COUNTRY</b>	ITALY
<b>PIPE DIAMETER</b>	Different – From 4'' to 30''
<b>PIPE LENGHT</b>	Different
<b>TYPE OF PROJECT</b>	Rehab of District Heating Pipeline
<b>COATED SECTION</b>	Application on Total Pipe Length
<b>GROUND CONDITION</b>	
<b>WEATHER CONDITION</b>	20°C
<b>Note</b>	Irregular shapes to be covered - curves, tees, etc

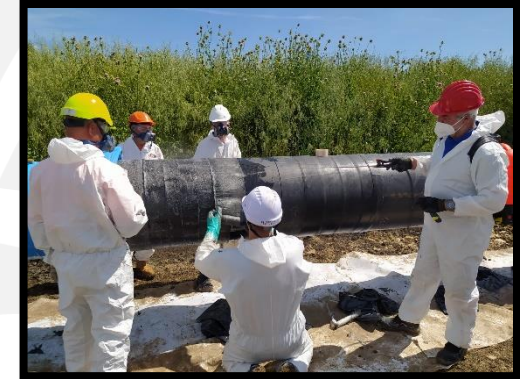
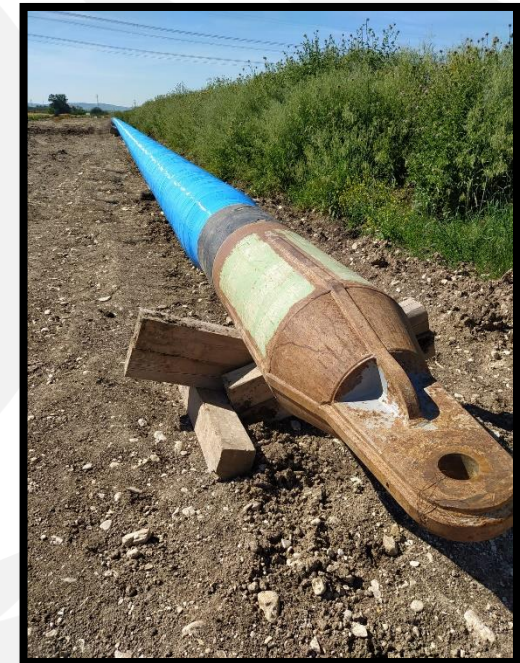
## SAN SALVO/BICCARI GAS PIPELINE

DATE	MAY 2022
OWNER	SNAM
CUSTOMER	<b>IMPRESA TRE COLLI</b>
COUNTRY	Italy
PIPE DIAMETER	26''
PIPE LENGHT	400 m
TYPE OF PROJECT	HIGH PRESSURE GAS LINE
COATED SECTION	Application on Total Pipe Length
GROUND CONDITION	
WEATHER CONDITION	25 - 30°C - Sunny
Note

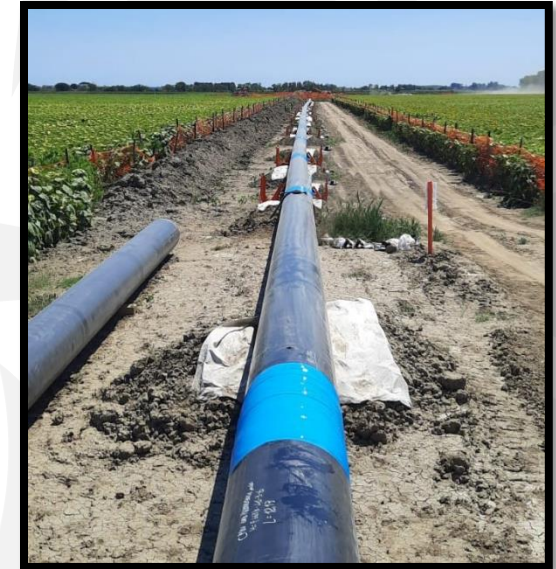
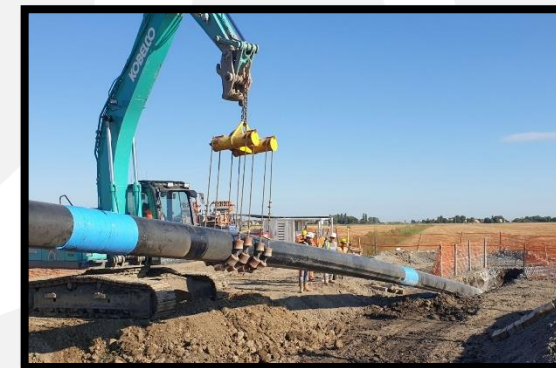
## RAVENNA/MESTRE GAS PIPELINE

DATE	JULY 2022
OWNER	SNAM
CUSTOMER	<b>FESTA S.P.A.</b>
COUNTRY	Italy
PIPE DIAMETER	DN 550
PIPE LENGHT	2100 m
TYPE OF PROJECT	HIGH PRESSURE GAS LINE
COATED SECTION	Field Joint Coating
GROUND CONDITION	
WEATHER CONDITION	25 - 30°C - Sunny
Note

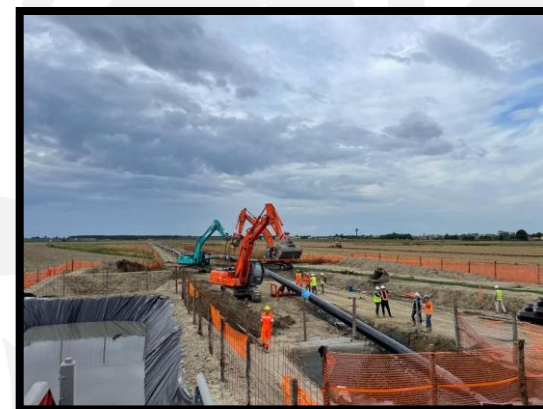
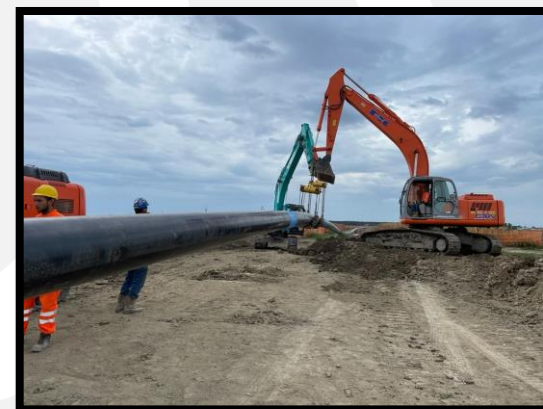
## RAVENNA/MESTRE GAS PIPELINE

DATE	SEPTEMBER 2022
OWNER	SNAM
CUSTOMER	<b>FESTA S.P.A.</b>
COUNTRY	Italy
PIPE DIAMETER	DN 550
PIPE LENGHT	2100 m
TYPE OF PROJECT	HIGH PRESSURE GAS LINE
COATED SECTION	Field Joint Coating
GROUND CONDITION	
WEATHER CONDITION	20 - 25°C – Sunny
Note

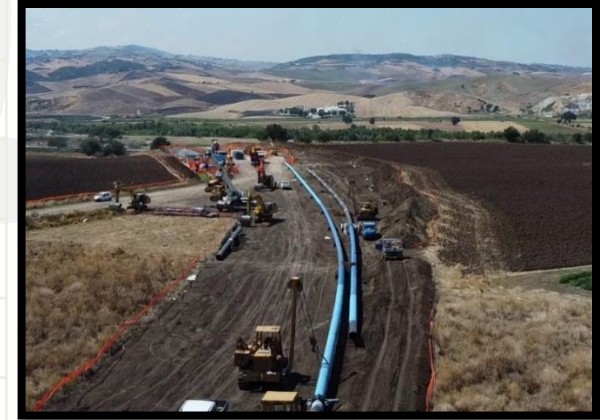
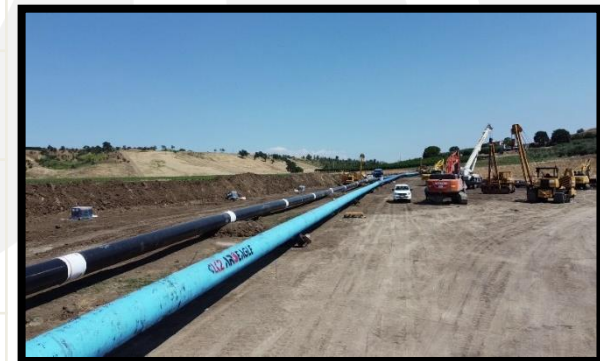
## SAN SALVO/BICCARI GAS PIPELINE

DATE	AUGUST 2022
OWNER	SNAM
CUSTOMER	<b>IMPRESA TRE COLLI</b>
COUNTRY	Italy
PIPE DIAMETER	26"
PIPE LENGHT	440 m
TYPE OF PROJECT	HIGH PRESSURE GAS LINE
COATED SECTION	Application on Total Pipe Length
GROUND CONDITION	Very critical soil, lot of gravel, rocky and pebbly ground
WEATHER CONDITION	Sunny, very hot > 30°C
Note
