# SAFETY Alert

N° 02/2023 Date: February 2023

**OBJECT: PIPE DROPPED ON RIGGER FOOT**

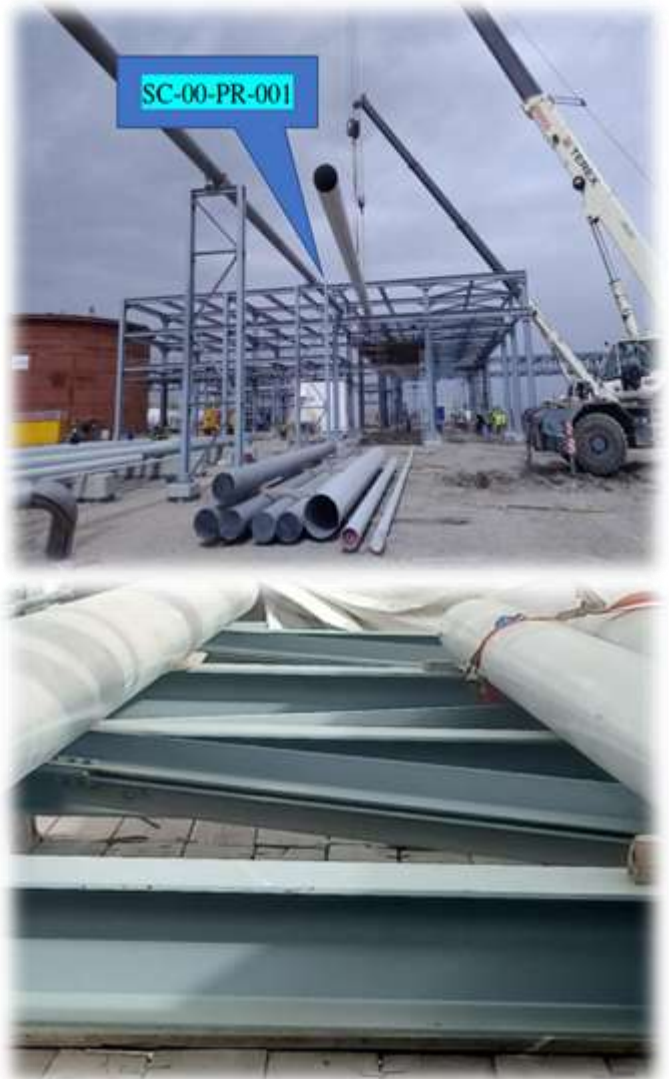
During the execution of lifting activities for the erection of pipe (24" 36m long) into the main pipe rack, the rigger went on a scaffolding to relocate the slings without securing the piping spool.

While the rigger was relocating the sling, the pipe made an unexpected movement and fell on the worker foot.

- Inadequate risk perception: the riggers didn't evaluate the risk of impact while untied the pipe.
- Risk Assessment / JSA not adequate: the JSA did not consider the hazards during slings shifting.
- Lack of / inadequate training and / or information: No specific toolbox talks performed with lifting crews.
- Failure to secure: The spool was not properly secured before the relocation of the sling.
- Improper placement / Improper position for task: The rigger should not be located between the suspended spool and the installed pipe.

- Develop a specific Toolbox Talk and Safety Alert to be shared with the entire workforce.
- All workers (including operators) must be trained and informed about Line of Fire hazards and stop work authority.
- Toolbox talks briefing shall be conducted by the site supervisor in order to inform workers about the potential hazards related to the activity.
- Ensure adequate supervision at jobsite for safe execution of site operations.
- JSA shall include the steps and relevant hazards regarding methods to secure the pipe before slings set – up or relocation.
